Corrosion Resistance of Steel Coated with Different Coating Systems, Containing HAA-Polyester Powder Coating as a Top Layer

This study aimed to assess the impact of surface geometry, preparation, and coating procedures on the corrosion behavior of HAA-polyester powder coated steel components in a salt spray test. The coating process of the steel parts involved degreasing, Zn spray coating, an epoxy powder primer, and a polyester powder topcoat. Results highlighted the crucial role of surface geometry, with flat surfaces showing superior corrosion resistance compared to welded joints, sharp edges, or hollow cylinders. For standard flat panels, no red rust was observed for over 600 hours in the salt chamber, meeting ISO 12944-6 requirements. However, non-standard panels with complex geometries showed rust much earlier, particularly after 108 hours in welded zones and sharp corners when an epoxy primer was not used. Applying the primer extended corrosion resistance by 2-3 times. Hollow cylinders developed rust after 240 hours due to insufficient coating thickness inside the cylinders. Crevices remained vulnerable, as the coating did not reach inner parts. Applying powder to individua

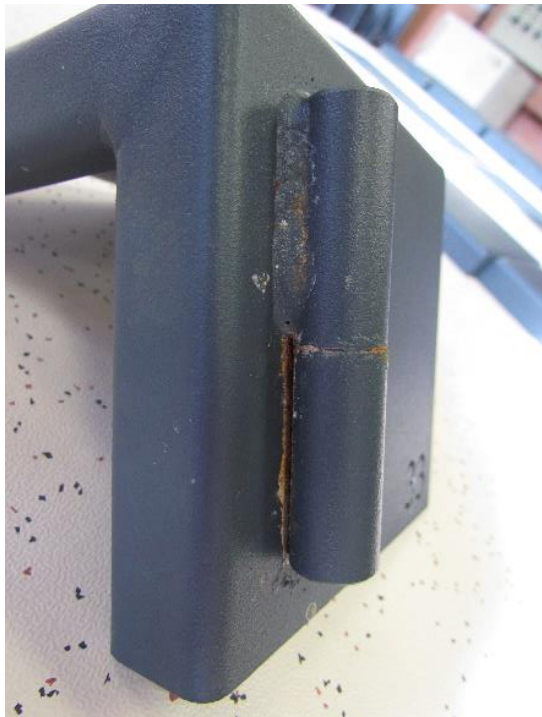
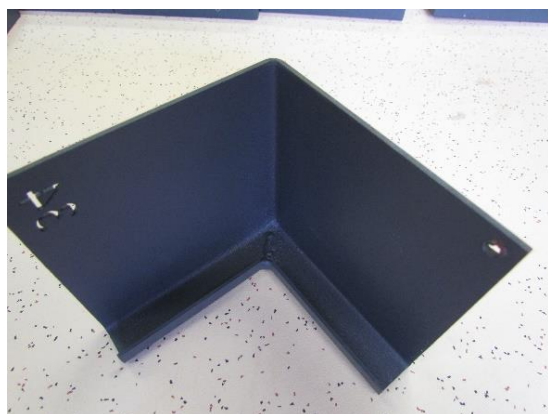
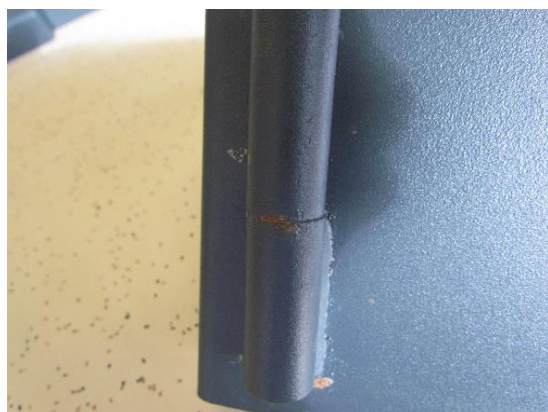
Figure 4. Sample No. 20 appearance after 348 hours in the salt chamber. The degree of rust is evaluated with 8 in the welded zone and with mark 3 at the hinge (in the crevice).

The samples with the welded hinge form a very compact group, in sense that all five samples (No. 19 to No. 23) lasted identical time in the salt chamber (348 hours) and that on all of the samples only the crevice corrosion is visible, between

the hinge and the flat metal surface (Fig. 4), as well as the corrosion in the welded zone that is of significantly lower intensity. It is important to stress out that the flat surfaces, the welded corners and the rolled edges remained intact and free

from rust, as it is also depicted in Fig. 4. It is obvious that the surface geometry plays significantly higher role in the protective action of the coating system, than the preparation process: the powder coating system applied may not protect the parts from crevice corrosion, but on the other side successfully protects the flat and rolled surfaces, independently on the preparation process applied, even independently on the fact whether the epoxy primer is present or not.
